Manhole Inspection Summary

Manhole # S47KK_022MH

Insp Date: **5/5/08 9:35 AM**

Location Address: **Patterson Park Ave**

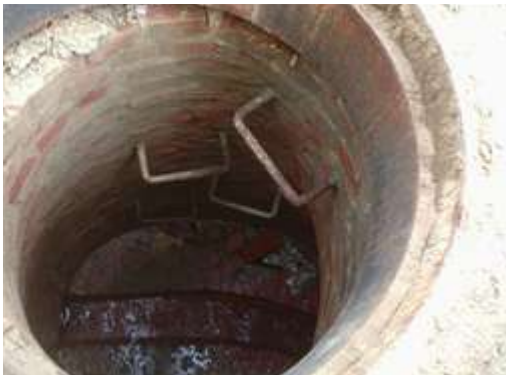
Defect 2

Condition: ☐ Sound ☐ Cracked ☐ Root Intrusion ☒ **Loose Brick** ☐ Deteriorated

Loose bricks

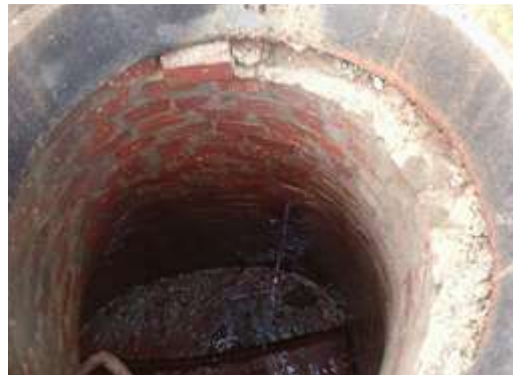
Defect 1

Deterioration

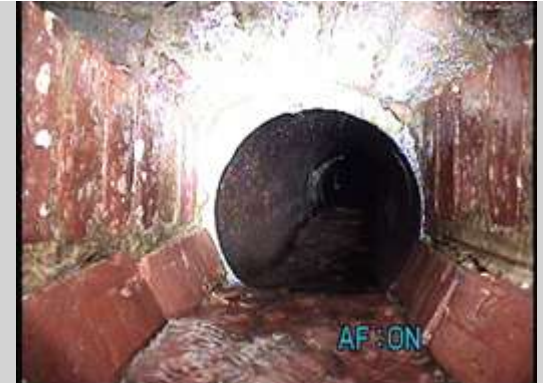
12 O'Clock Outflow

8 in. Circular Gravity Sewer
Pipe Out @ 12 O'Clock

Pipe Height: **8.4** (in.) Rod and Bar (Angled)
Pipe Material: **Clay** ☐ Pipe Lined
Invert Depth: **8.30** (ft.) Flow Characteristics: **Fast**
Deposits: ☒ None ☐ Mud ☐ Sludge ☐ Debris ☐ Grease
Silt Depth: (in.) Deposits Extent:
Infiltration: **None** Pipe Seal Cond: **Sound**

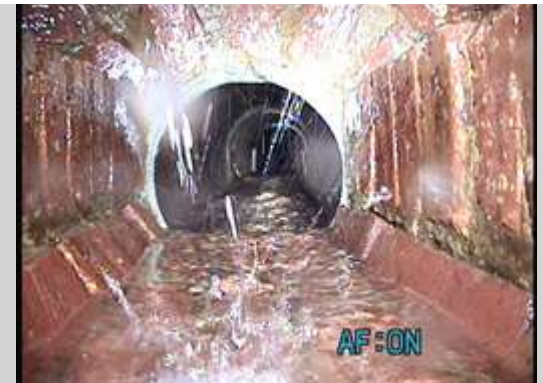
6 O'Clock Inflow

8 in. Circular Gravity Sewer
Pipe In @ 6 O'Clock

Pipe Height: **8.4** (in.) Rod and Bar (Angled)
Pipe Material: **Clay** ☐ Pipe Lined
Invert Depth: **8.25** (ft.) Flow Characteristics: **Fast**
Deposits: ☒ None ☐ Mud ☐ Sludge ☐ Debris ☐ Grease
Silt Depth: (in.) Deposits Extent:
Infiltration: **None** Pipe Seal Cond: **Sound**
